Superfund 3rd Five-Year Review Report Smith's Farm Landfill Brooks, Bullitt County, Kentucky

Smith's Farm Landfill
5-Year Review Final Report
September 2006

Third Five-Year Review Report

**Smith's Farm Landfill
Brooks, Bullitt County, Kentucky
September 2006**

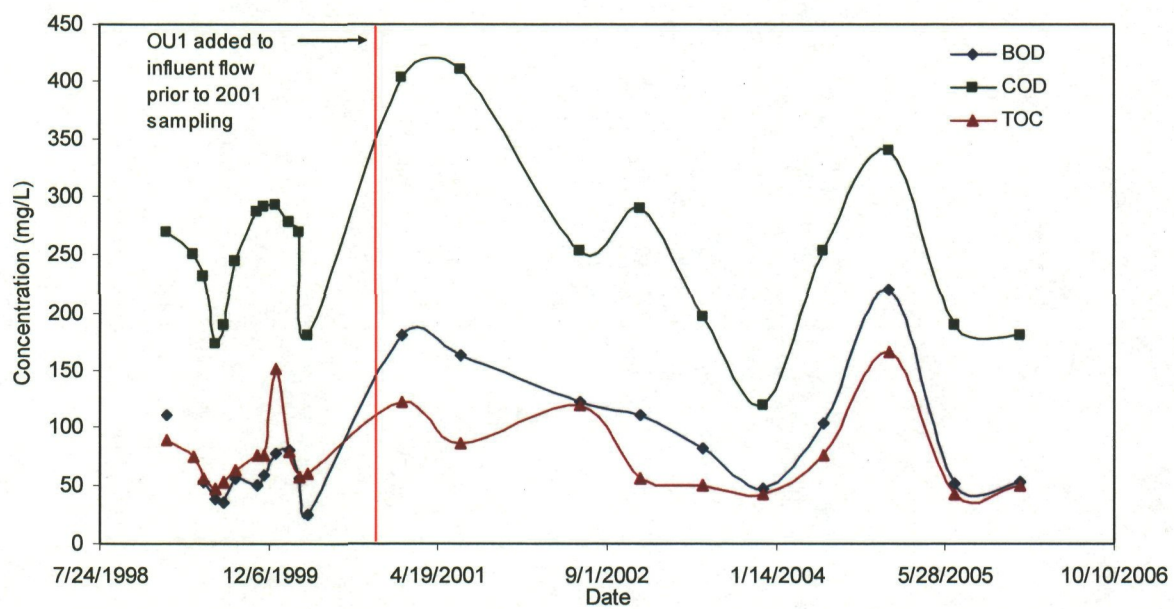
Figure 11
BOD, COD and TOC influent concentrations with time
Smith's Farm Landfill
Brooks County, KY

Influent and effluent data have been provided in tabular form, but have not been graphed by the contractor to provide a site conceptual description of change in contaminant concentrations time. These are suggestions for inclusion in annual reports, so that reviewers and decision makers have a chronological understanding of the concentrations of contaminants at the site and the effectiveness of treatment. A simple plot of some of the influent parameters in Figure 11 suggests an increase in treated contamination after the addition of OU1 to the treatment facility in 2001. The subsequent decline of these parameters is followed by peaking concentrations in early 2005. The variation supports need for continued treatment. Comparison of influent and effluent concentrations show the facility is adequately removing contaminant from the area. It does not, however, provide

Data Reporting	Annual reports should plot the influent and effluent concentrations versus time to show annual variability and overall site progress	PRP	EPA	2006 Annual Report	N	N

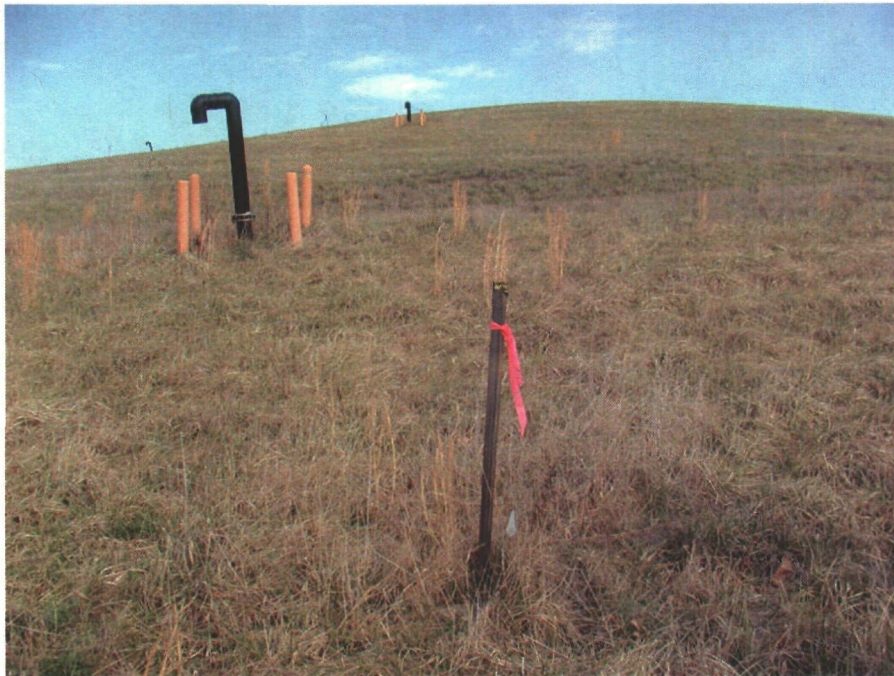
monuments are placed and are surveyed for this purpose (Photo 9). On March 16, 2006, MACTEC stated that the tilt of the gas vents have been evaluated to determine whether the tilt compromised the release of gas from the subsurface. Results suggest that the gas is able to sufficiently release efficiently, as the tilting is minor.

Photo 9- OU2: Marker for elevation monument (foreground), and gas vents (back)

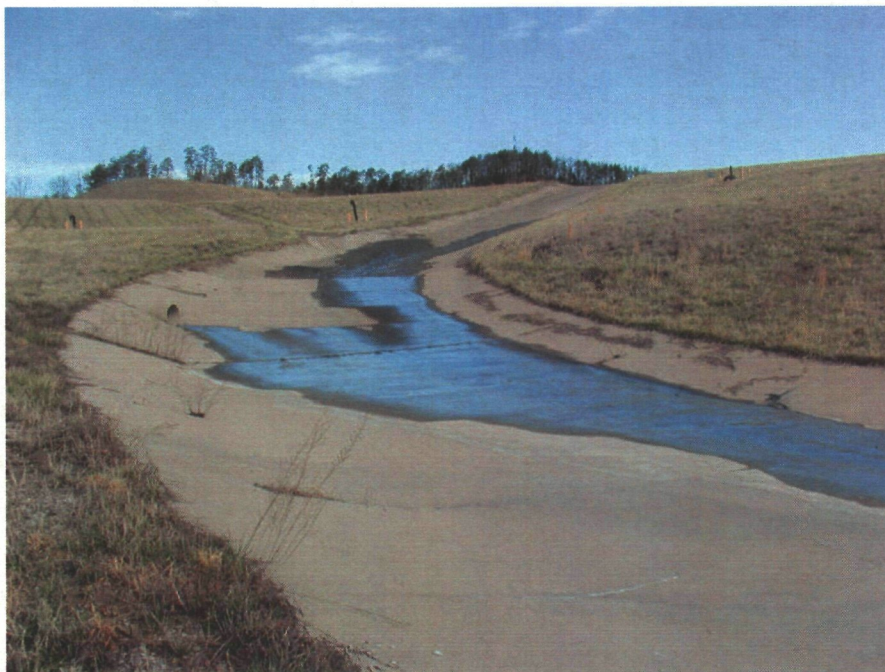
- Repair of landfill cap access road from paved road to top of southwest slope, including placement of specified dense graded aggregate mix for filling of erosion gullies and resurfacing of the road (Photos 10, 11), re-grading of the road surface, (including crowning of road), placement of select soil fill and re-grading of areas adjacent to road, and application of asphalt prime and seal coats;

Photo 10- OU2 Surface Drainage Feature

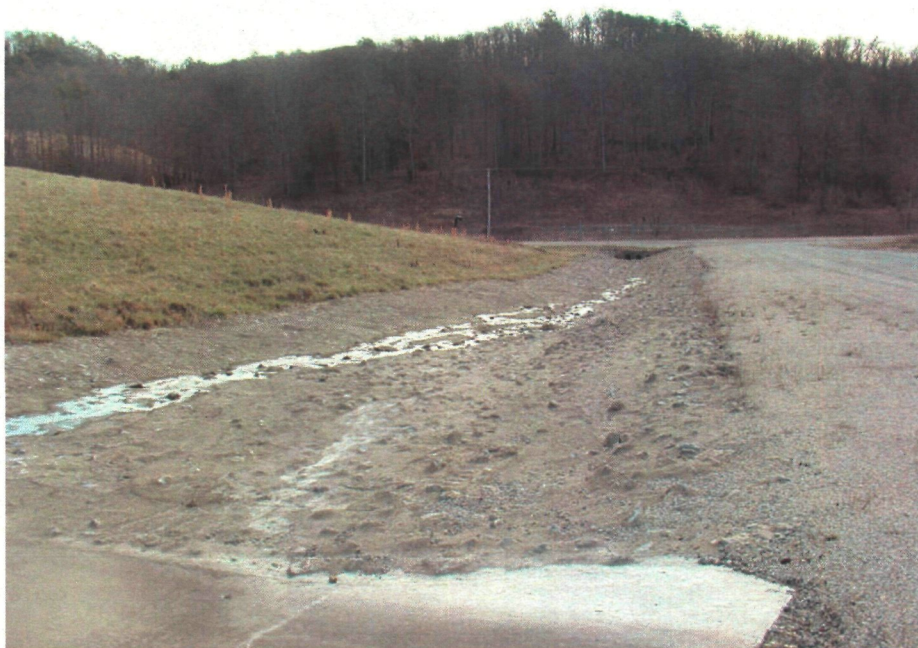
Photo 11- OU2 Surface Drainage Feature

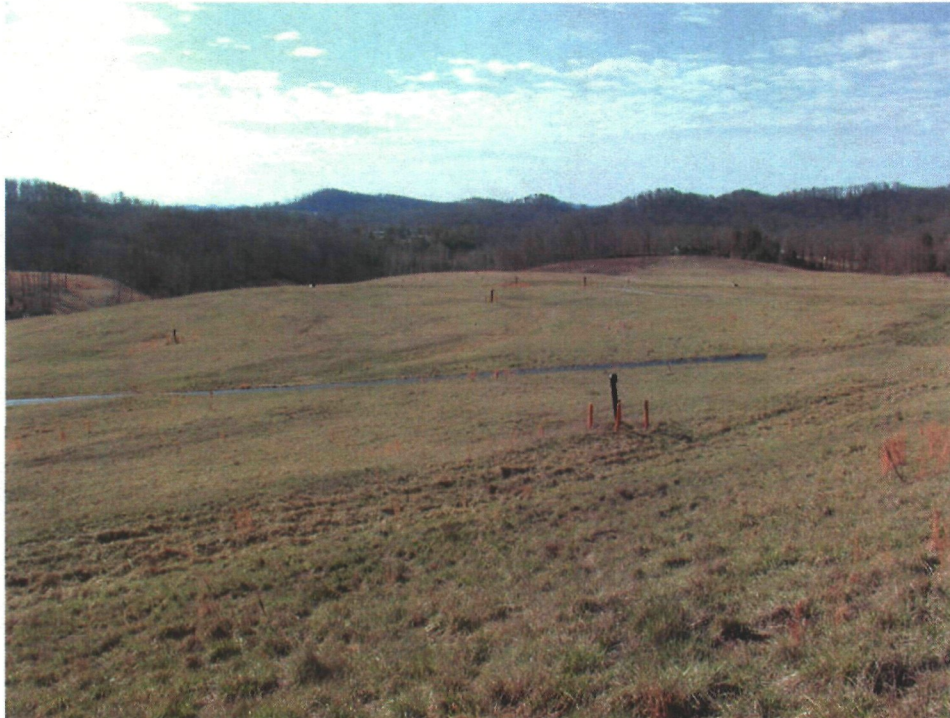
Due to the slope of the landfill and the strategic location of interceptor ditches/benches, there was no evidence of ponding on the cap. The benches slow down runoff velocity, intercepts and directs it to lined letdown channels (Photos 15, 16). Letdown channels descend down the steep south slope which collect runoff by the benches. These channels are lined, rip-rapped and grouted and in good repair.

Photo 15- View Across Peak of OU2: Start of letdown channel, mid-photo. Looking south

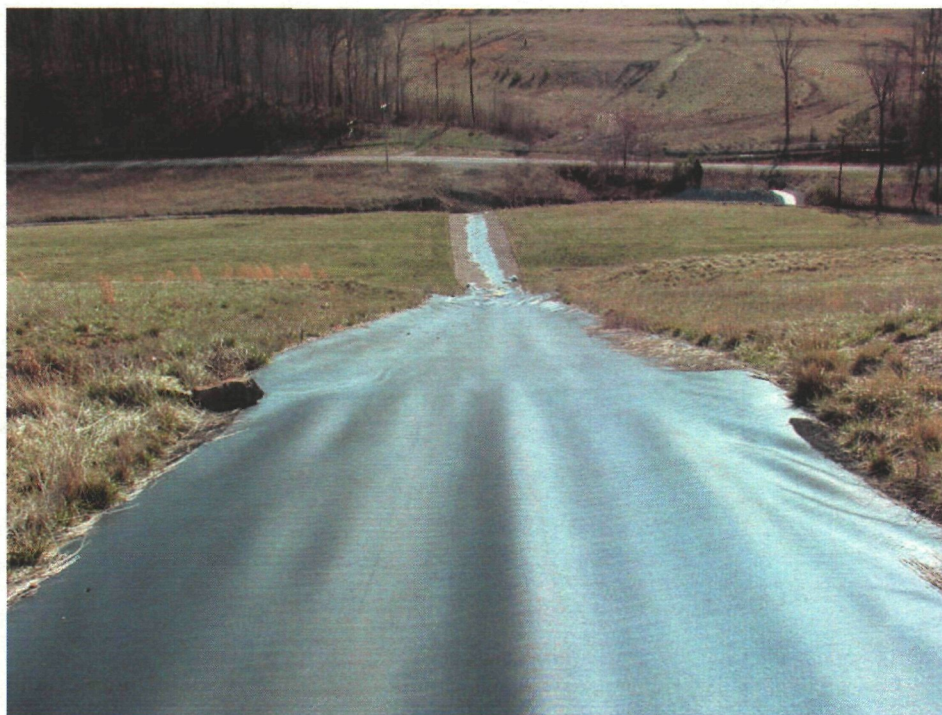
Photo 16- OU2 Typical Letdown Channel, looking east

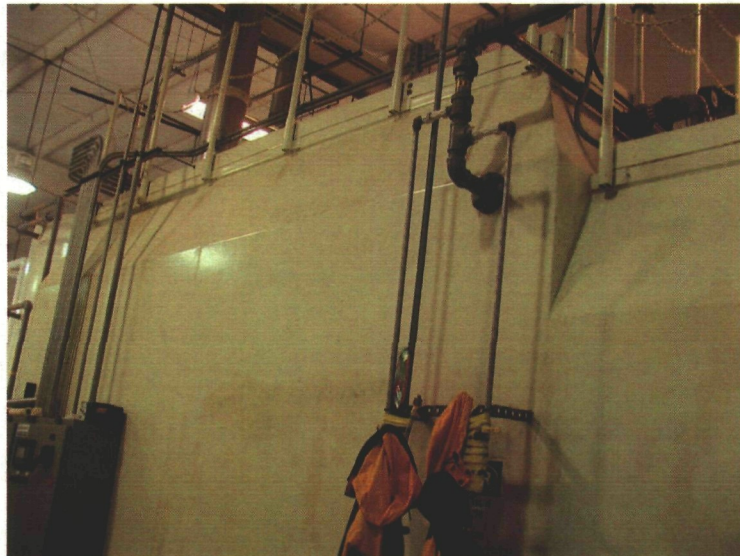
Photo 30- Package Sequencing Batch Reactor (SBR)

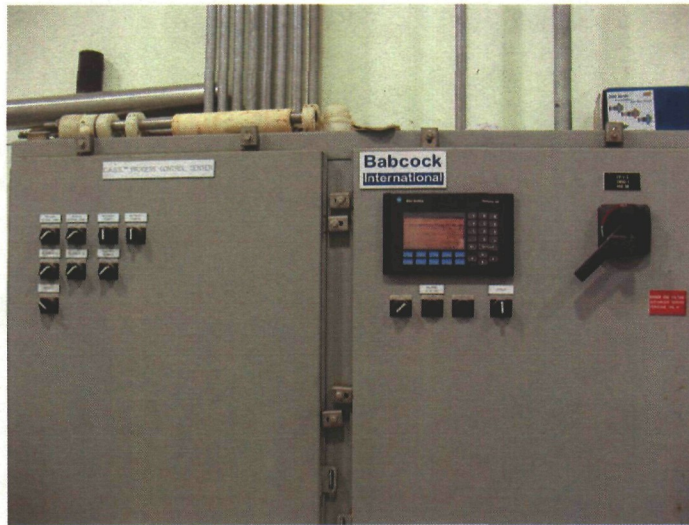
Photo 31- Package Sequencing Batch Reactor (SBR) Control

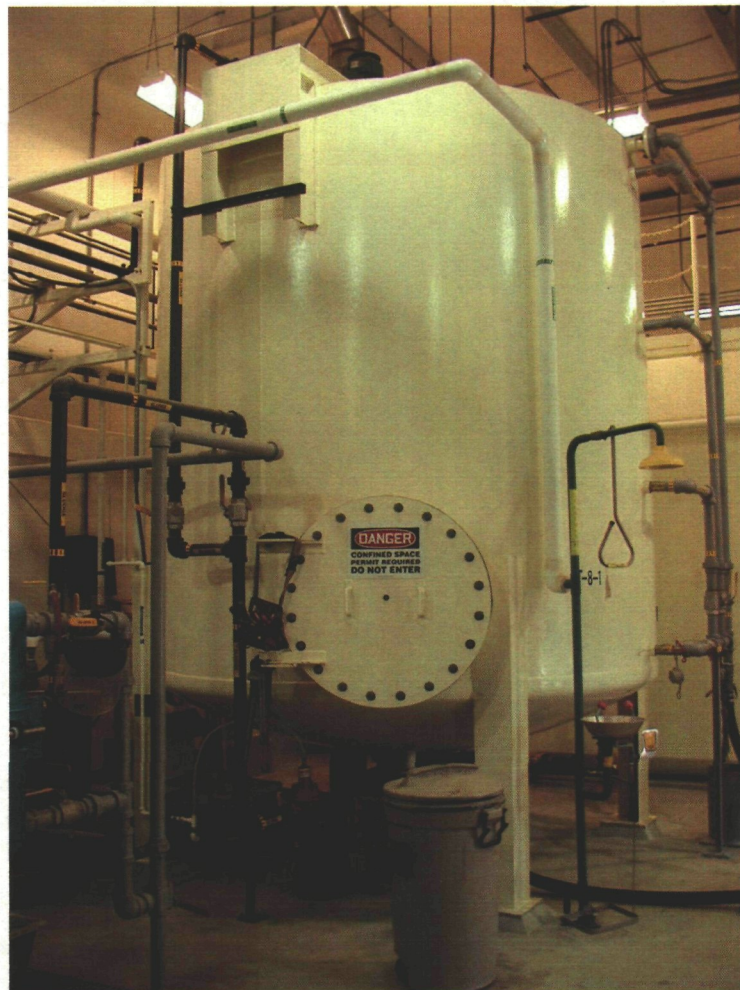
The sludge thickening tank (Photo 32) provides the operator the ability to decant water from the settled sludge. Excess water in the sludge thickening tank is decanted when there is sufficient sludge volume to dewater (the tank should be at least half full). Decant valves at several liquid heights are used to decant the excess water. An 8-inch length of clear pipe, installed downstream from the decant valves, allows the operator to see when sludge is encountered so that the operator knows when to stop decanting. The decant water is discharged to the building sump where it is then pumped back to the SBR inlet. The decanting process thickens the sludge and reduces the volume of material to be dewatered. The sludge thickening tank is designed to increase the solids content of the sludge to approximately 2.5 - 4 percent solids by weight. The sludge is thoroughly mixed in the tank and the material is pumped to the filter press.

Photo 32- Sludge Thickening Tank (T-8-1)

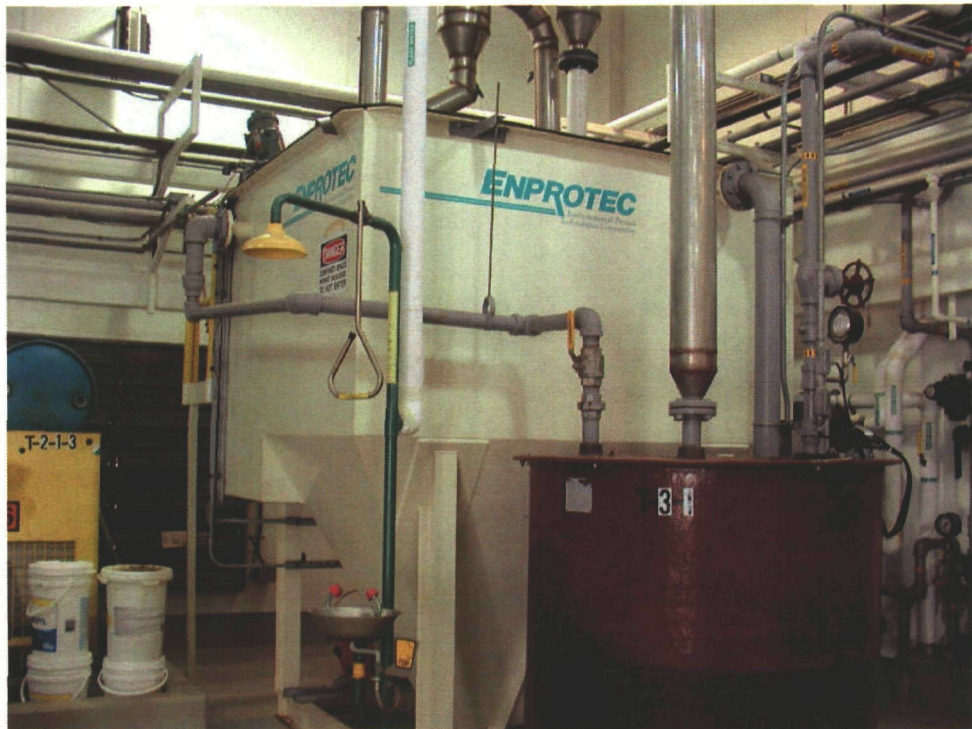
The packaged metal removal unit (Photos 33) uses pH adjustment, flocculation, clarification, and sedimentation to reduce the concentration of metals in the leachate. The system consists of a large tank which is divided into a flash mixing zone, a flocculation zone and a clarification zone. In addition, the system utilizes three chemical sources: a 20 to 50 percent concentration sodium hydroxide storage tank (T-2-1-1), a 50 percent concentration sulfuric acid storage tank (T-2-1-3), and an anionic polymer day tank (T-2-1-2). The design throughput of the MR system is 28,800 gallons per day (or 20 gpm).

Photo 33- Package Metals Removal Unit (MRU)

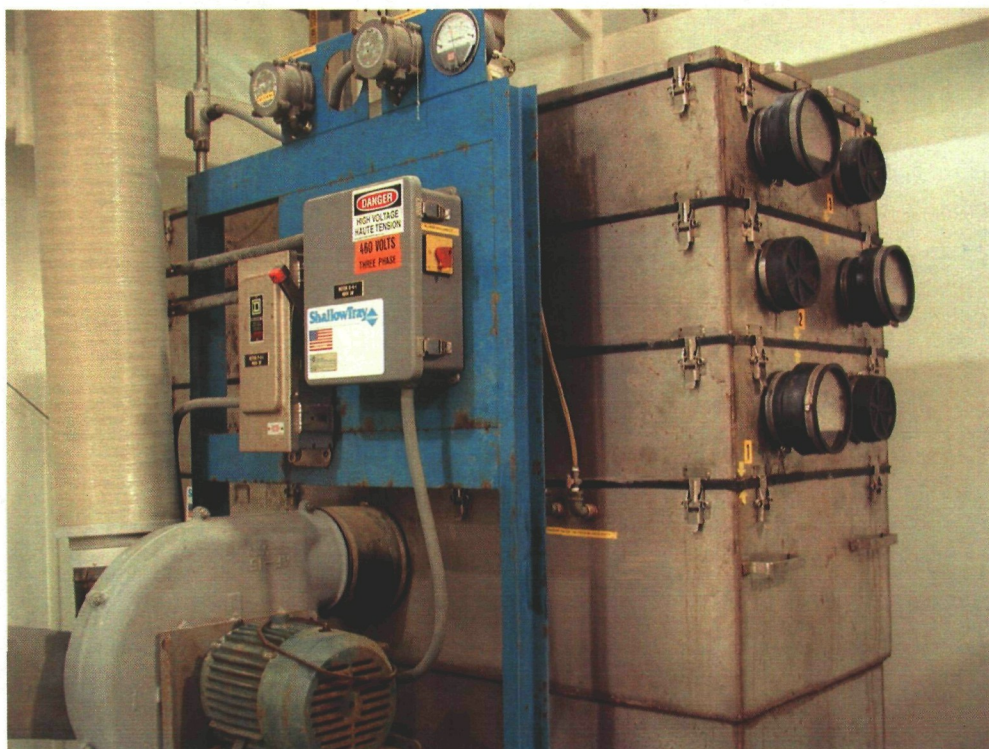
The low profile air stripper (R-4-1) (Photo 34) is a packaged unit that uses air-water contacting to transfer volatile organic constituents from the influent water stream to the air stream. This contacting is accomplished on a series of aeration trays within the air stripper unit. Effluent from the MR system flows to the air stripper feed tank (T-3-1), which acts as an equalization tank to ensure a relatively constant flow to the air stripper. Effluent water from the air stripper is pumped to the carbon vessels (T-6-1 and T-6-2) for final polishing before discharge.

Photo 34- Package Low Profile Air Stripper (R-4-1)

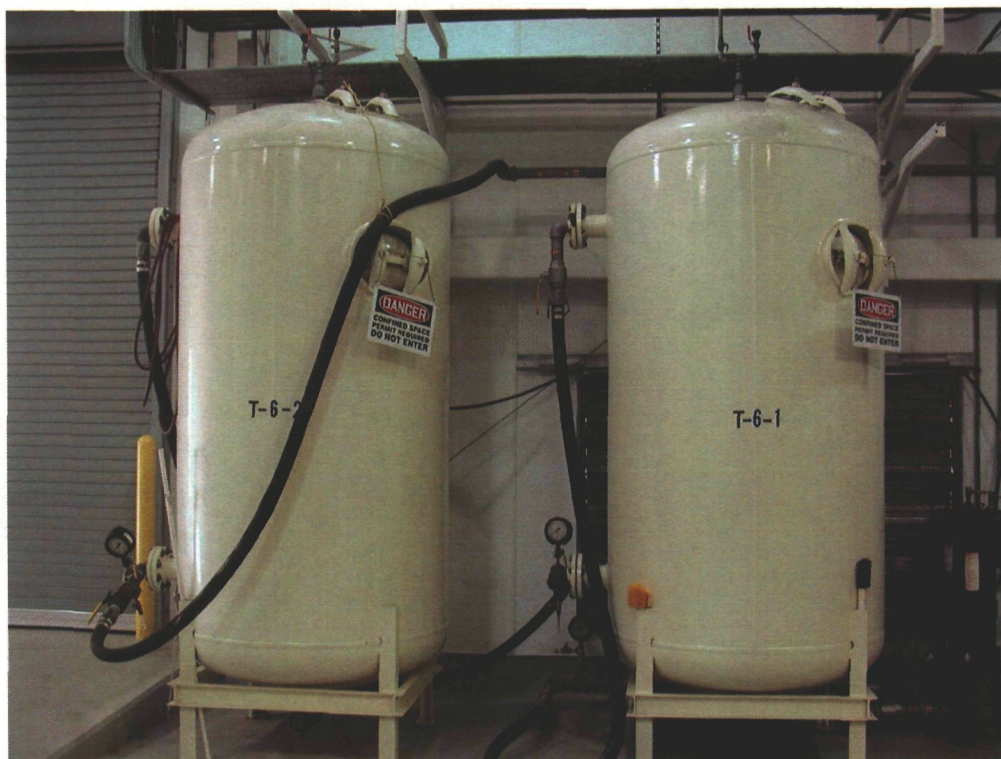
The carbon adsorption polishing system consists of two steel vessels filled with granular activated carbon (Photo 35). Each carbon vessel is sized to treat a maximum flow rate of 75 gpm. The design flow rate of each vessel is 20 gpm. The carbon vessels are also capable of operating in either parallel or series should additional capacity or reduction in effluent concentration be required. Standard operating procedure at the Smith's Farm OU2 Landfill is to operate the carbon vessels in series. Periodic sampling of the effluent from the primary vessel monitors for breakthrough of organic constituents (which means the carbon no longer removes the constituents to non-detect levels) exiting the first vessel. When breakthrough occurs, the plant operator switches flow to the secondary vessel which becomes the primary vessel and calls the carbon supplier for replacement of the spent carbon vessel. The primary purpose of the system is to remove residual organic compounds in the treated leachate leaving the low profile air stripper. The system is designed to operate 24 hours per day with a pH between 6.0 and 9.0, and water temperature ranging from 50 to 68°F.

Photo 35- Granular Activated Carbon Vessel- Polishing

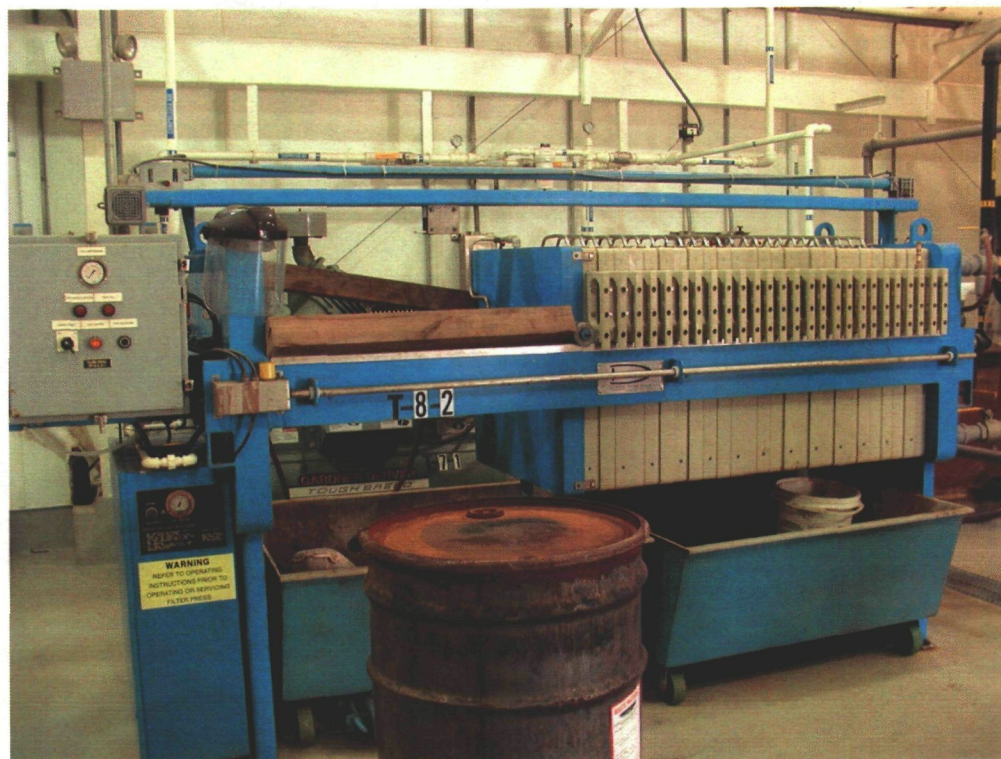
The sludge dewatering system consists of a packaged filter press unit (Photo 36). The

Photo 36- Package Filter Press- Sludge Dewatering

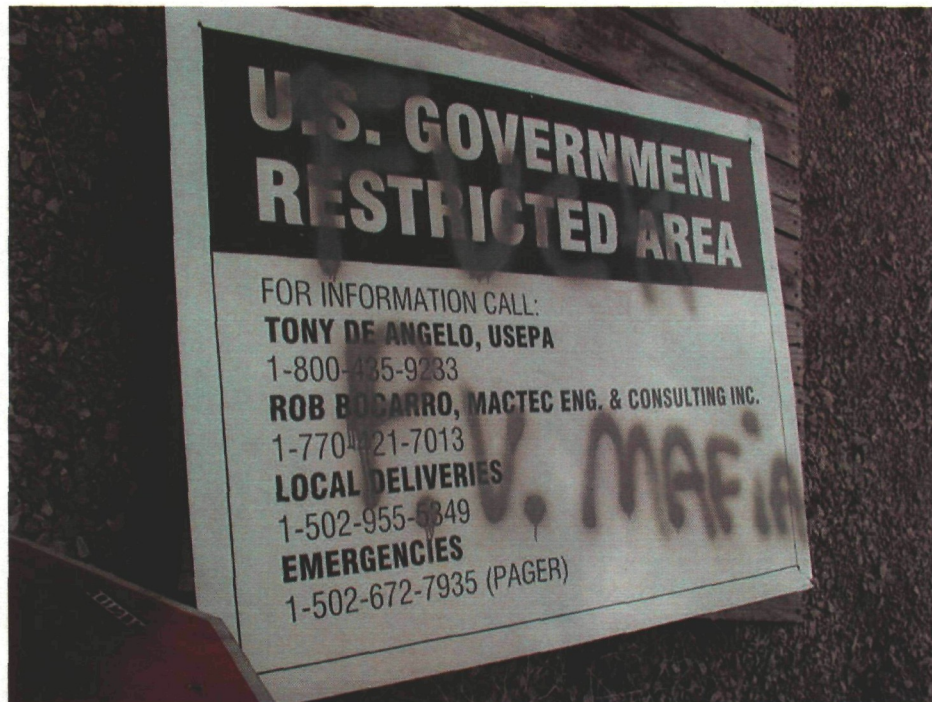
Photo 42- Sign Vandalism

D. General				
1.	Vandalism/trespassing	Location shown on site map	No vandalism evident	
	Remarks	Ongoing issue, Vandalism evident, Signs replaced are removed (stolen or shot) within days/weeks of replacement; gates repaired often

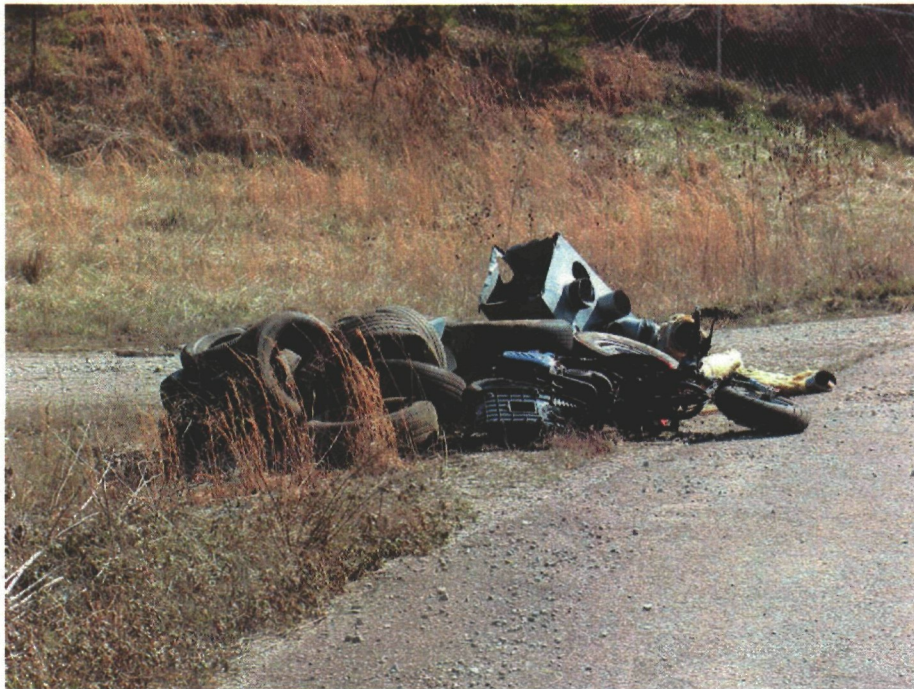
Photo 43- Onsite waste pile.

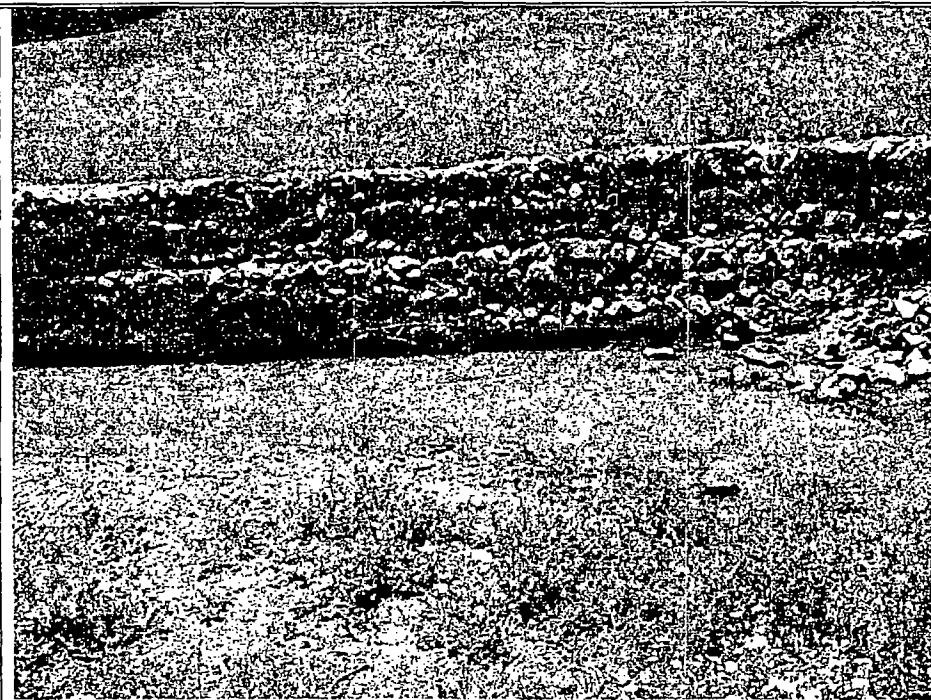
Gabion washout in creek, OU-2 perimeter at Sta # 533 (see photos # 6, 7 and 8)

Photograph 6: GABION WASHOUT

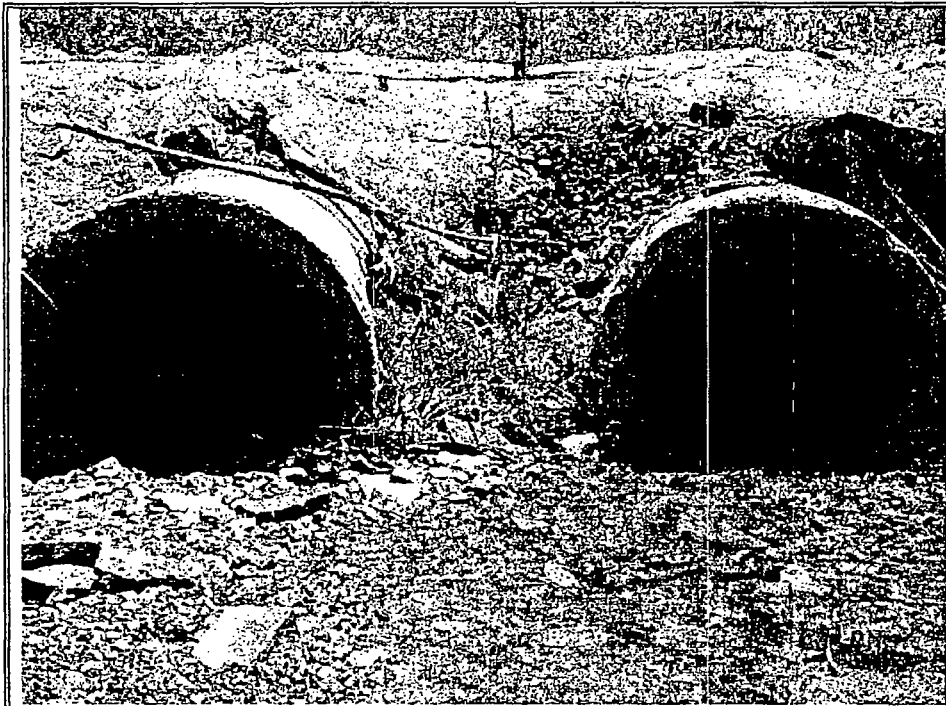
Photograph 11: CLOGGED CULVERT
